# KINGSTON ASH RECOVERY PROJECT

## MONTHLY REPORT

July 2012

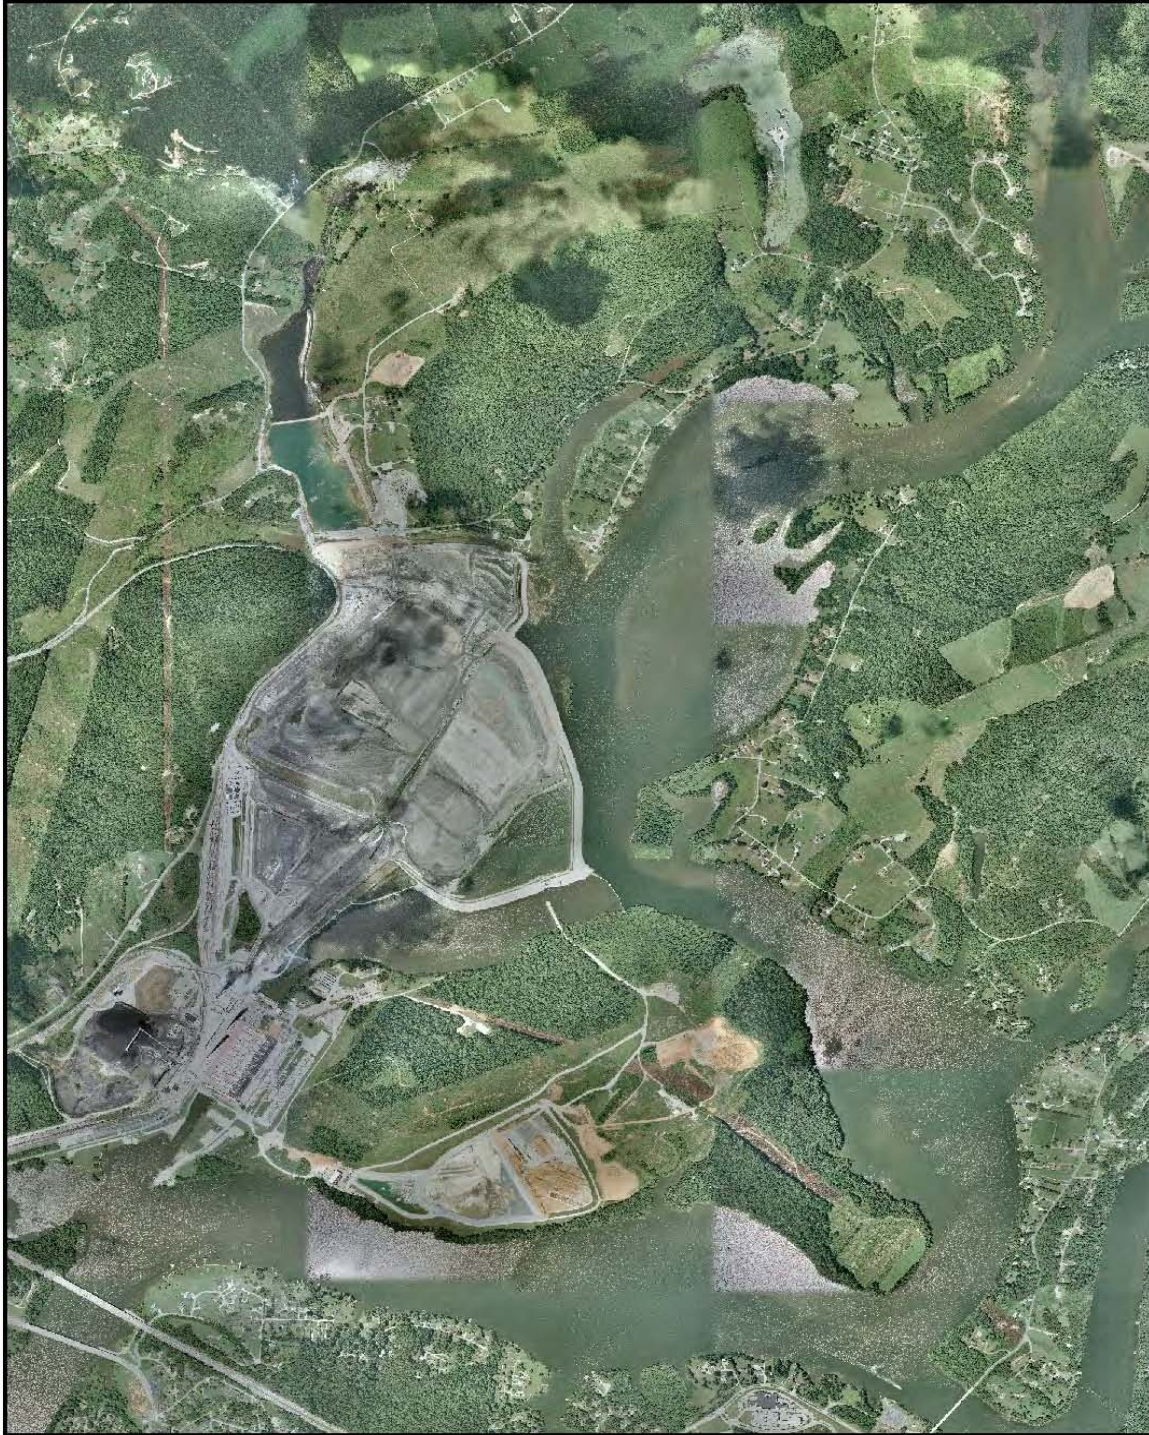
**Aerial Image of Kingston Ash Slide (07/26/2012)**

Date of imagery: 07/26/2012

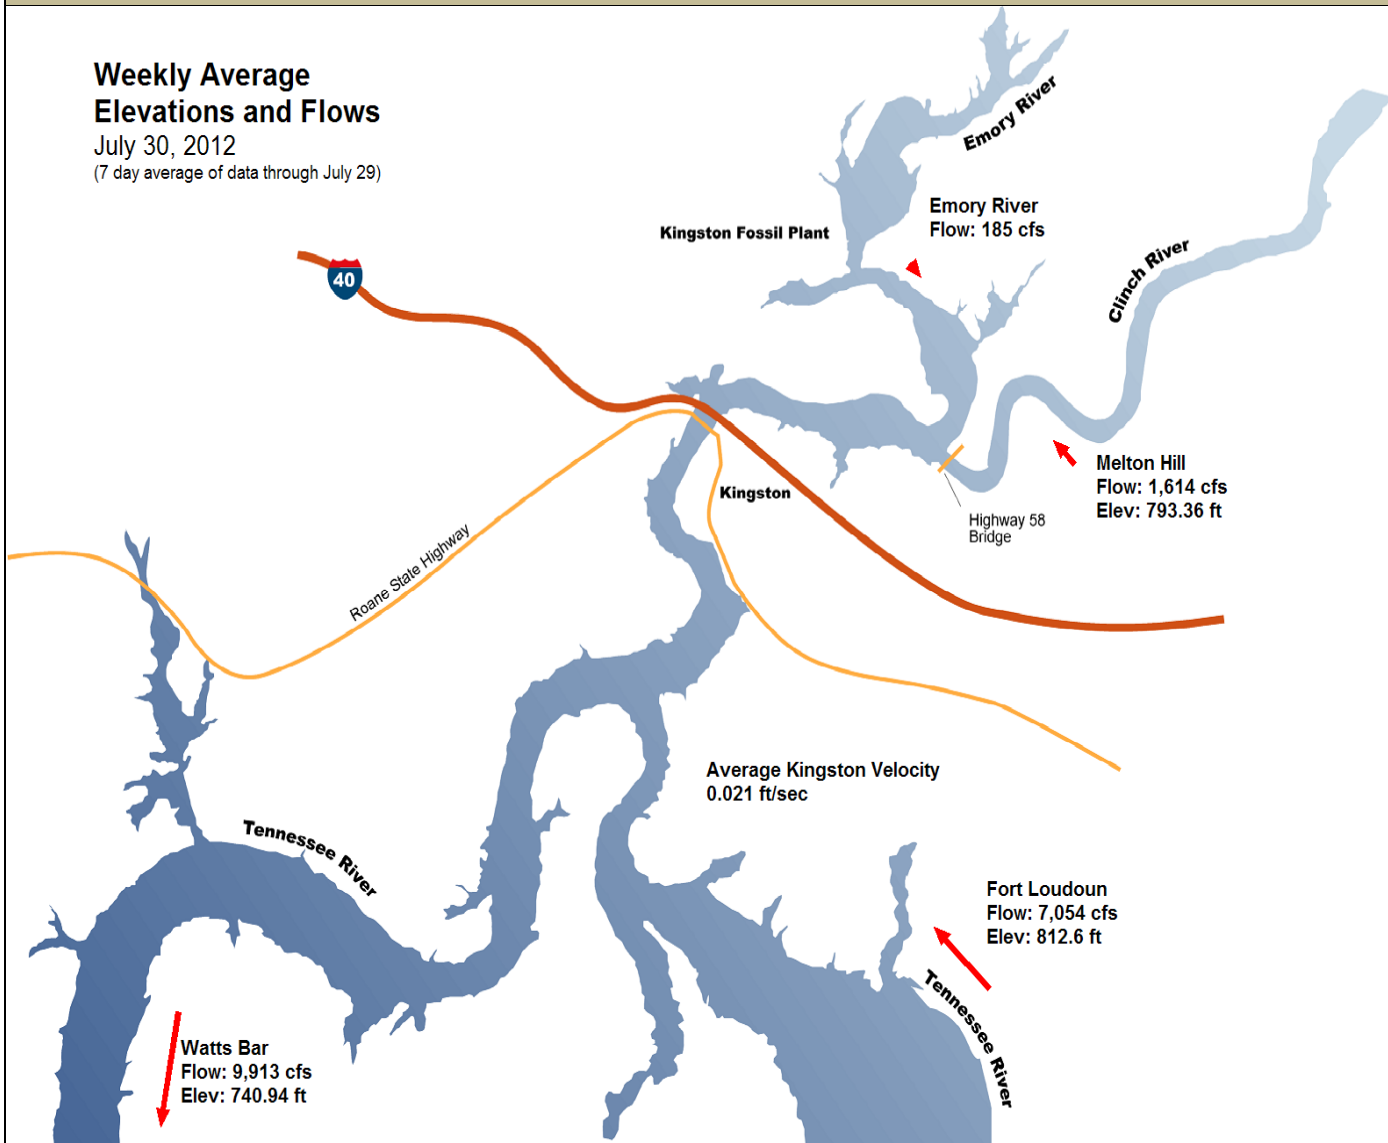
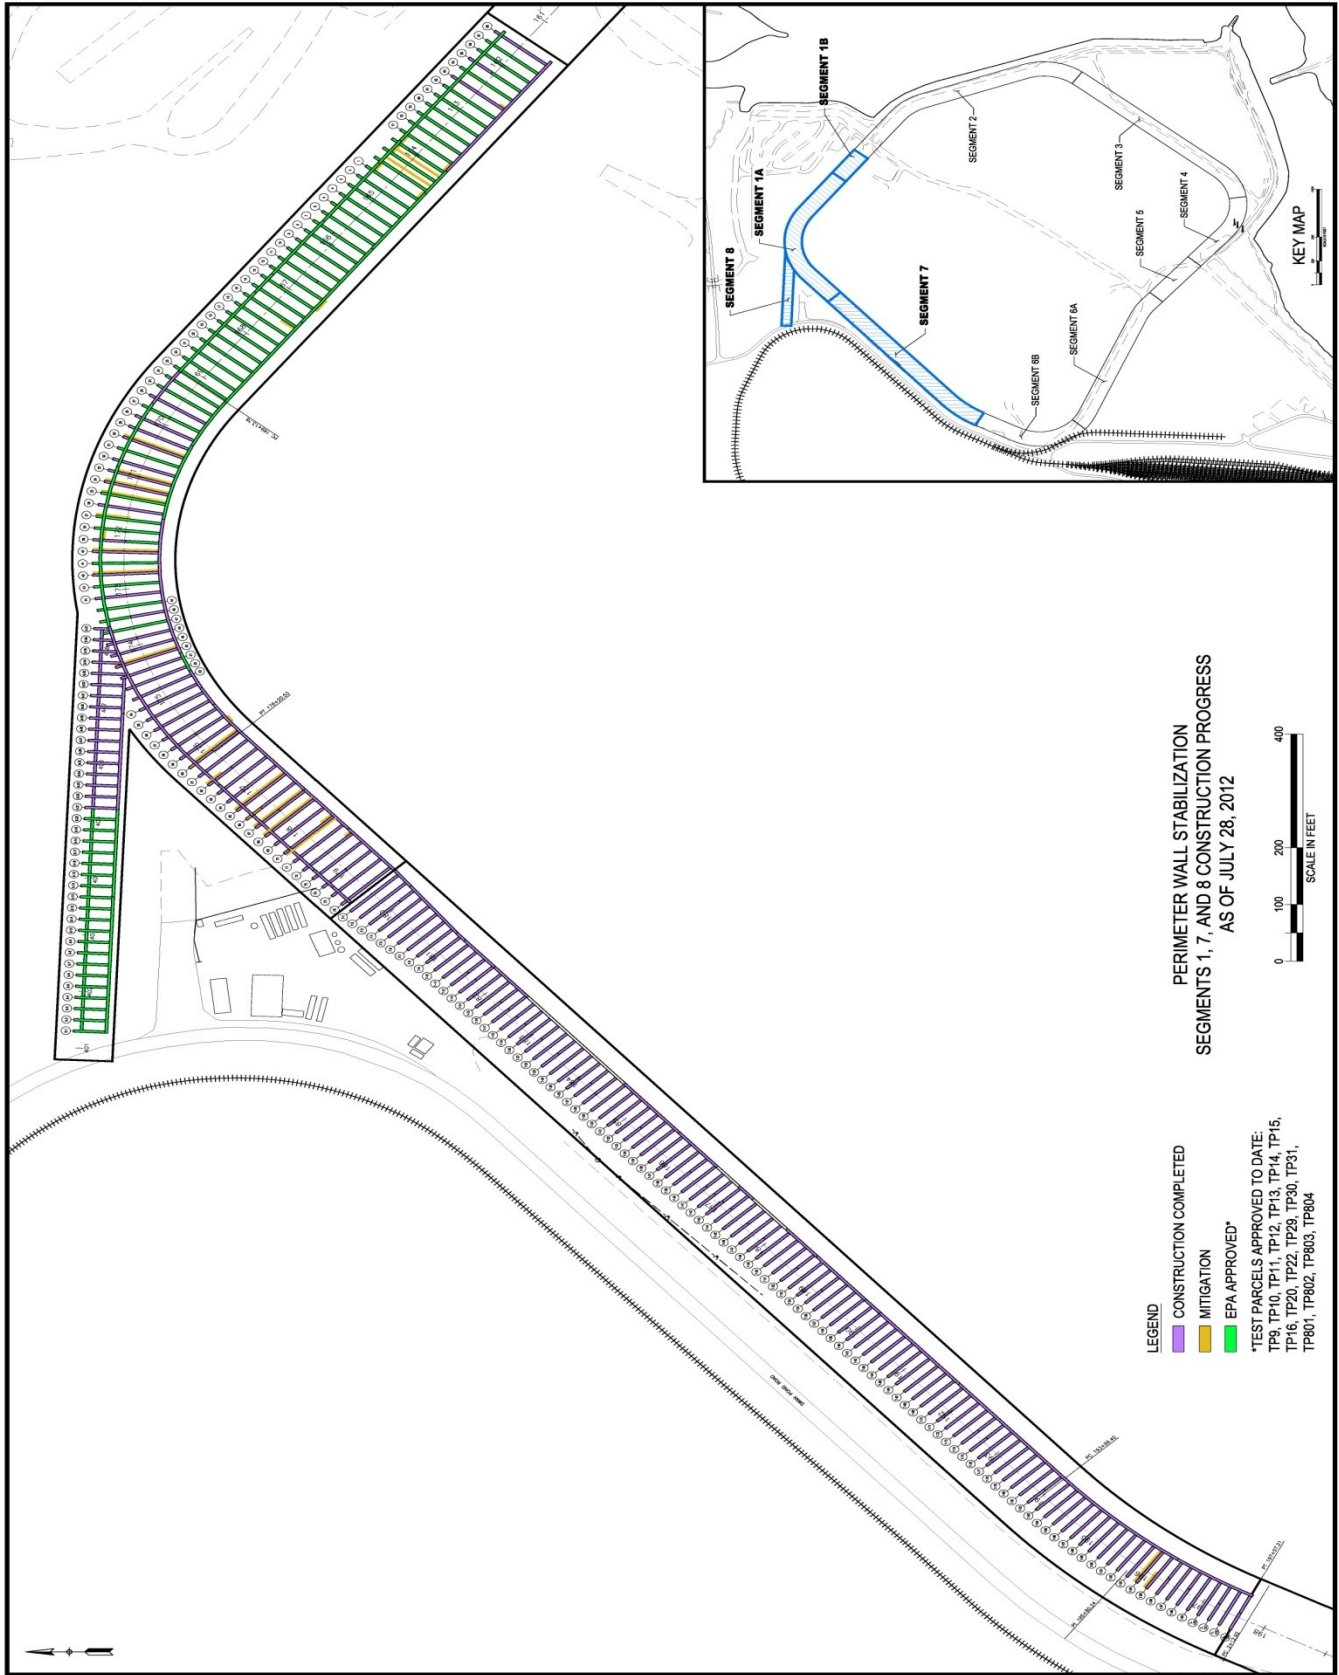
### Weekly Average Elevations and Flows

July 30, 2012  
(7 day average of data through July 29)

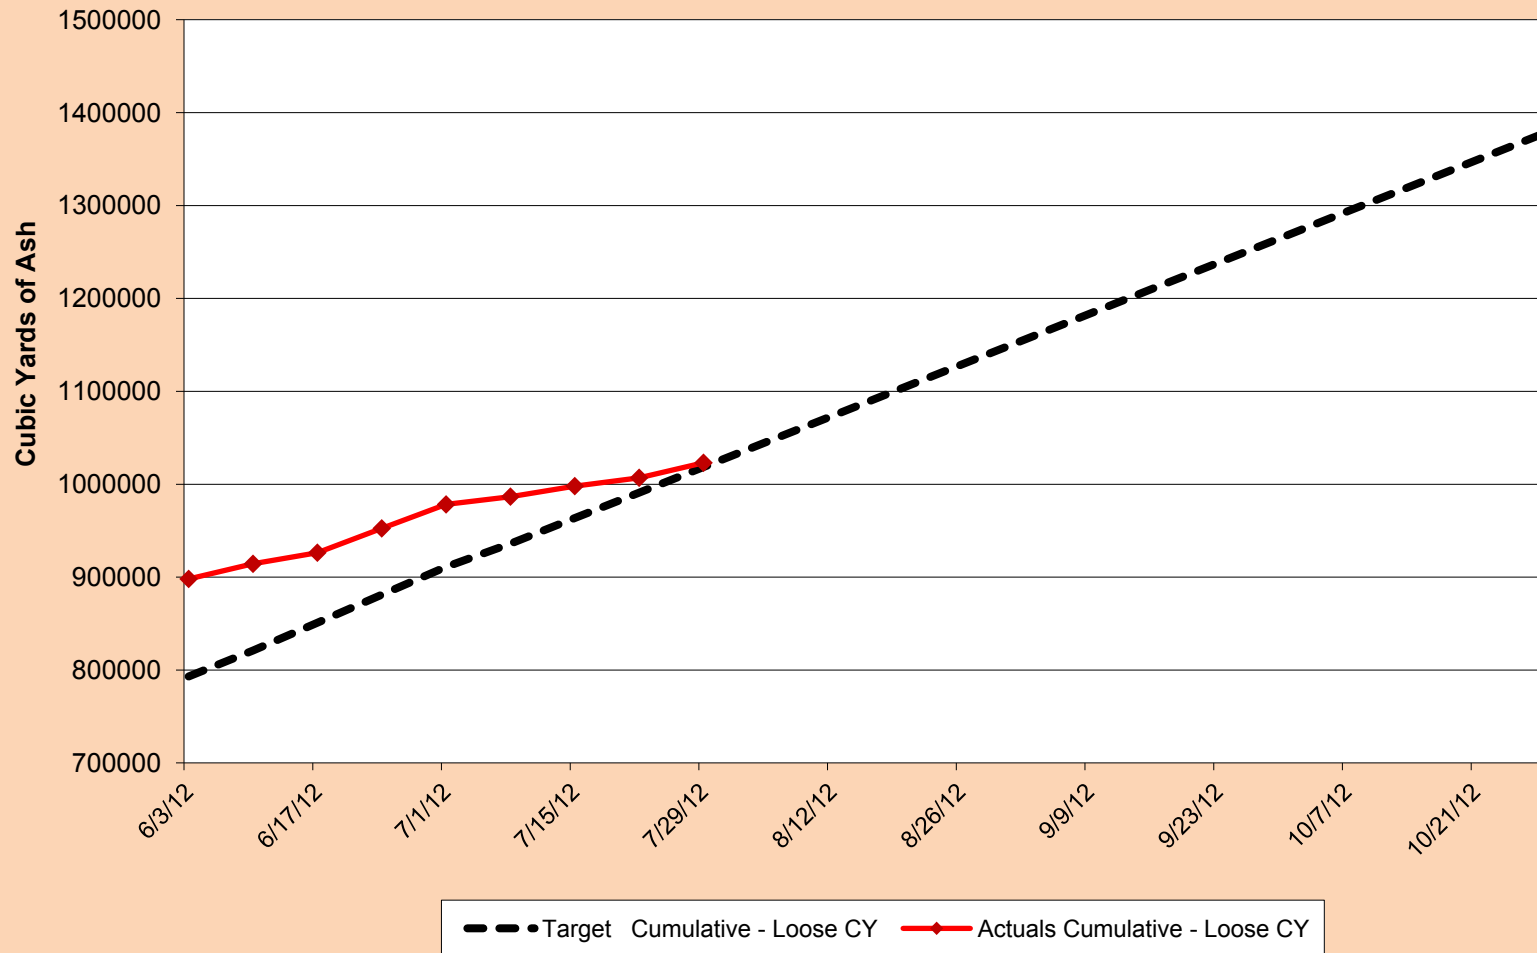
### Ash Excavation from Middle Embayment Weekly as of July 29, 2012

- Ash removal from the middle embayment was performed during the month and cumulative excavation remained ahead of target.
- Weekly middle embayment status reports were submitted.
- NTC concurrence KIF-12-001 was approved. Work on the second and third concurrence submittals was underway at month's end.
- Flow from Church Slough was connected to the North Embayment flows in the Clean Water Ditch after completion of ash removal and clay berm construction in area of concurrences KIF-12-001 and 002.
- Construction of a clean haul road from the underpass, along the Clean Water Ditch and continuing south along Swan Pond road was on schedule and should be completed in August.

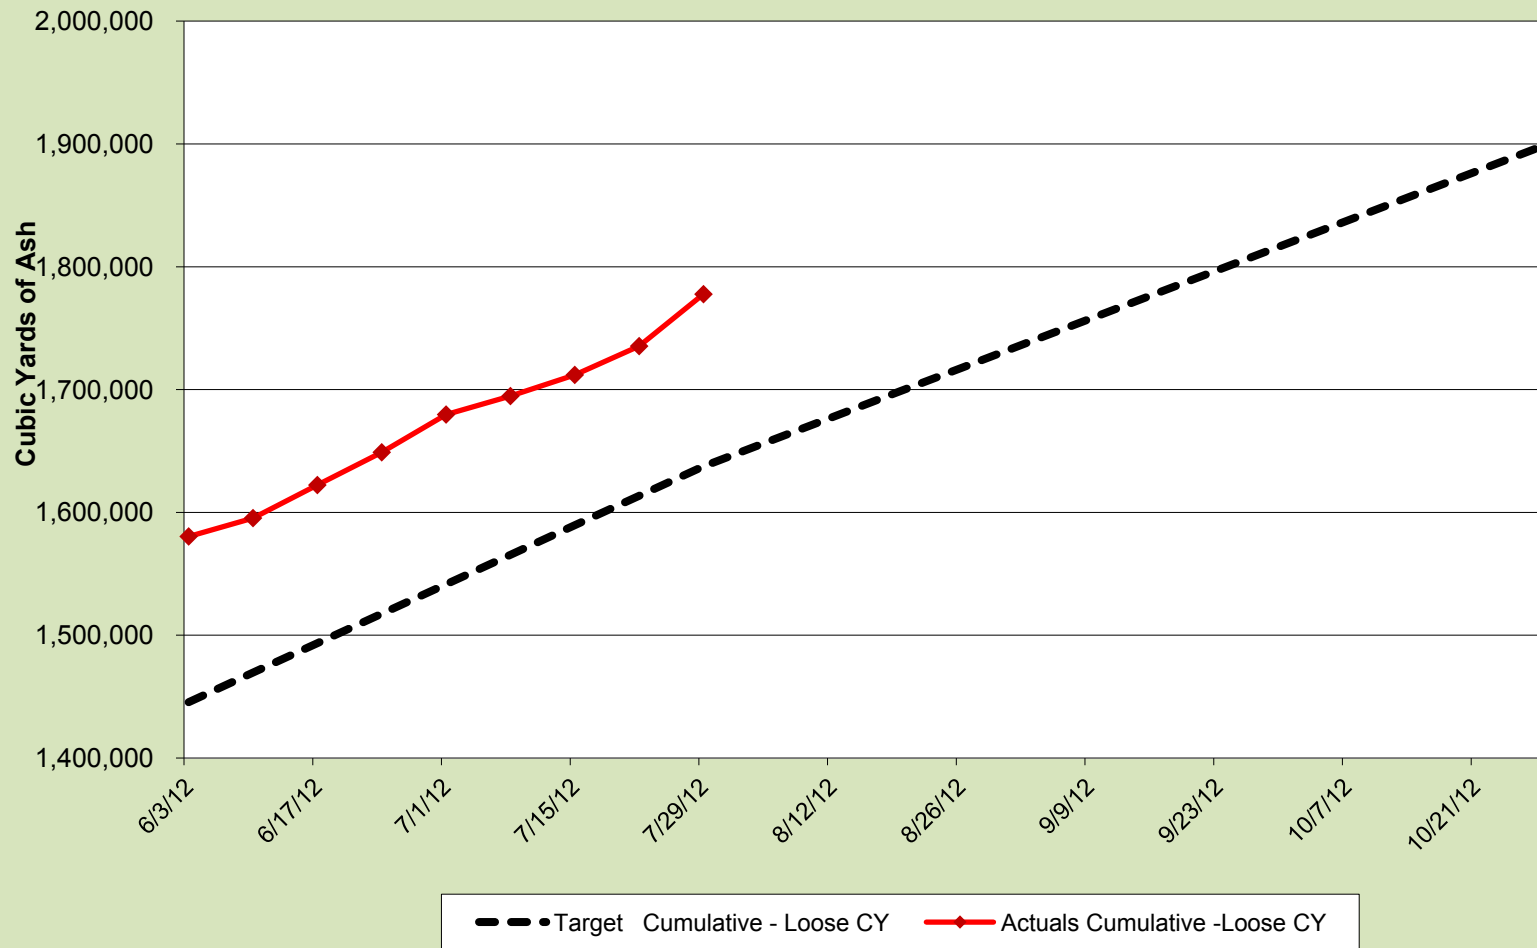
### Ash Stacking in Dredge Cell Weekly as of July 29, 2012

- Geo-Con continued construction of PWS wall in Segment 7 and completed mitigation wall repair in Segments 1 and 8.
- Ash stacking continued in the central dredge cell and alongside Dike D.
- Griffin continued pumping from well points in PWS Segment 7 and began pumping from 60-foot deep well points.
- CP continued drying materials in the relic area of the southern dredge cell (and in the drying pits next to Dragline Road during wet weather) and hauling from the relic to active ash stacking.
- TVA held meetings to discuss instrumentation reading interpretations and options for jet grouting of defects. Geo-Con then prepared a test plan and completed the field test for jet grouting of defects.

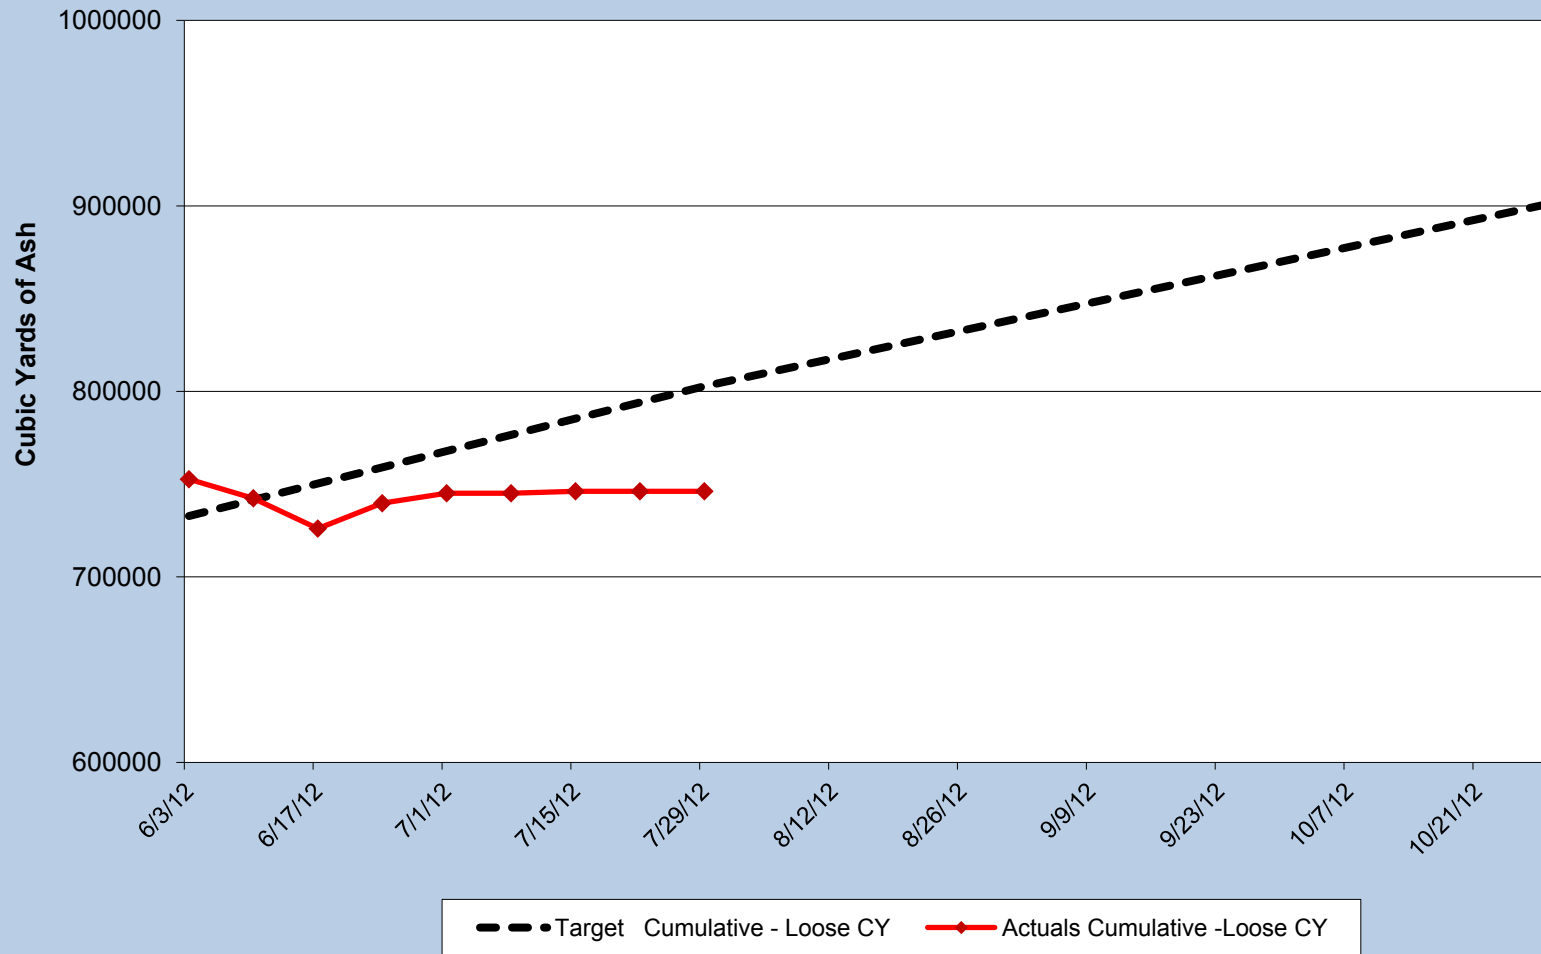
### Ash Stacking in Lateral Expansion Weekly as of July 29, 2012

- A stop work order was issued by Stantec due to rate of movement measured in inclinometers. A counterweight stacking was begun to slow this movement. Once stacking resumes, restrictions will remain in effect that limit stacking to a maximum of 1 foot per day, with guidance to limit stacking in any given area to once per week.
- Small quantities of ash and spoils were placed in the ash pond in preparation of the subgrade prior to stacking.
- Regulators approved the design drawings for the lateral expansion perimeter containment (Segment 2) and the sluice trench outlet piping. Stantec submitted 100% IFC drawings.
- Stantec submitted the 30% design drawings for the ash pond perimeter containment (Segments 3 and 4).

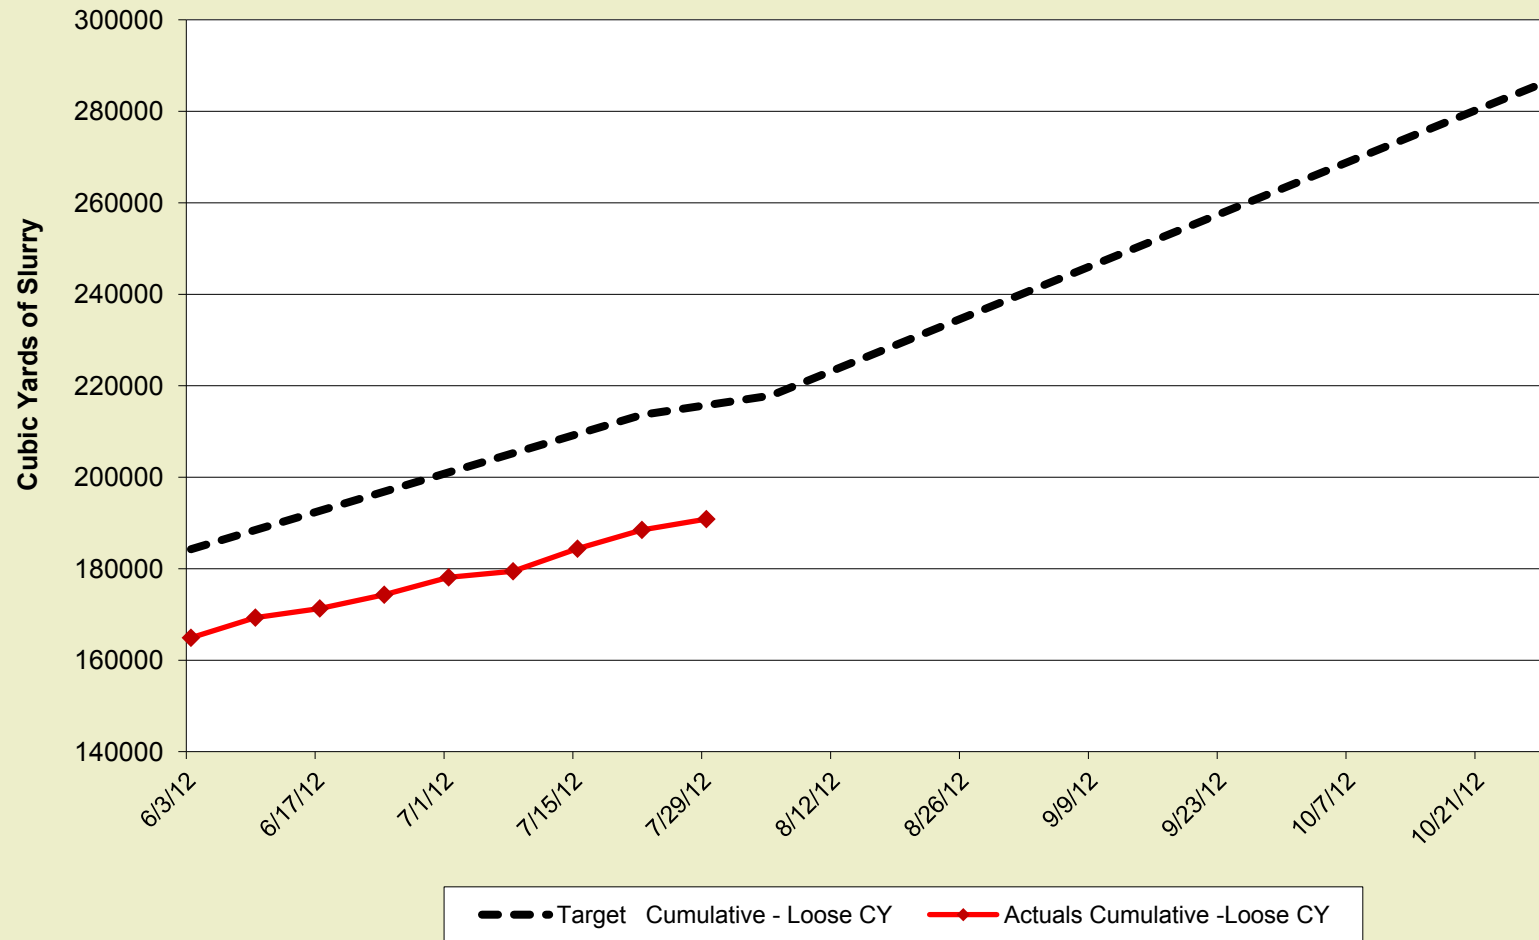
**Perimeter Wall Stabilization Segment 1A, 1B,8 & 7  
Weekly as of July 29, 2012**
